**National Endowment for the Humanities
Condensed Environmental Assessment**

**Georgia O’Keeffe Museum of Santa Fe County
Georgia O’Keeffe Museum**

**Challenge Grant Program
Grant No. CHA-268762**

July 19, 2024

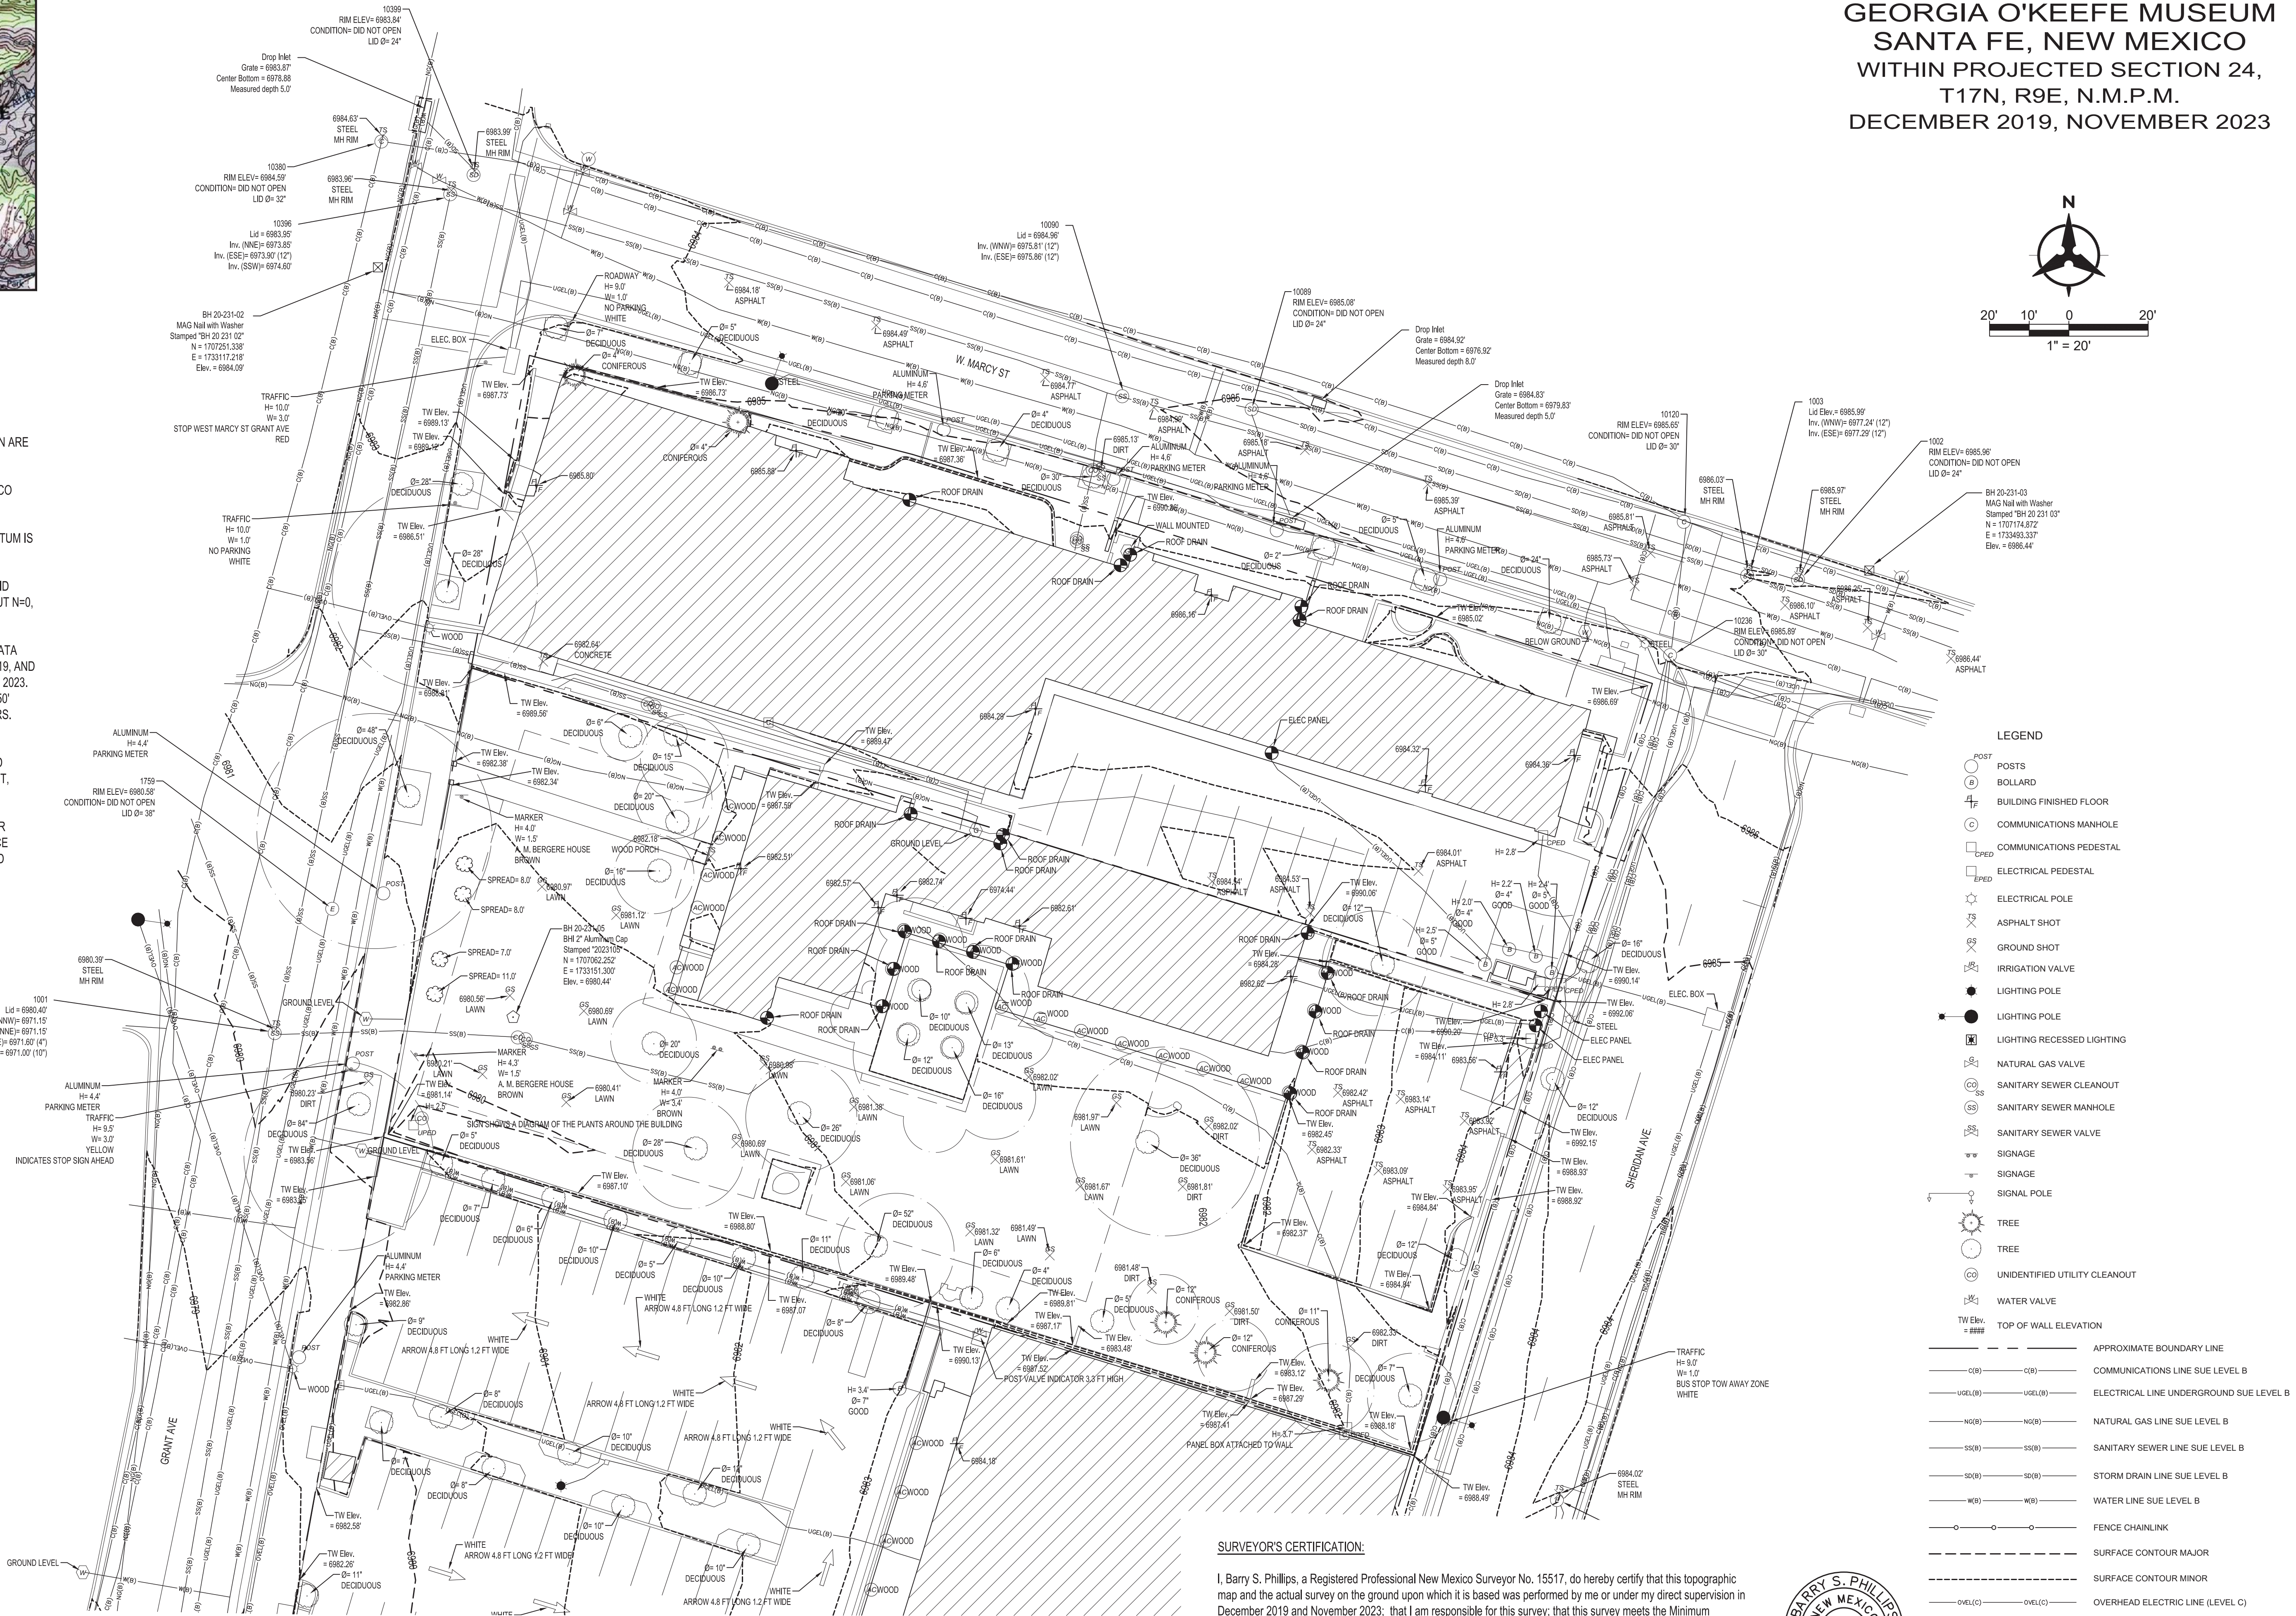
- UTILITIES SHOWN WERE LOCATED IN THE FIELD BY BHI STAFF, AS PER MARKS SPOTTED ON THE GROUND FROM SUE Level B UTILITY SERVICE PROVIDED BY HIGH MESA CONSULTING GROUP - SEE PLAN PROVIDED SEPARATELY AND DATED 11-2019.

TOPOGRAPHIC MAP
GEORGIA O'KEEFE MUSEUM
SANTA FE, NEW MEXICO
WITHIN PROJECTED SECTION 24,
T17N, R9E, N.M.P.M.
DECEMBER 2019, NOVEMBER 2023

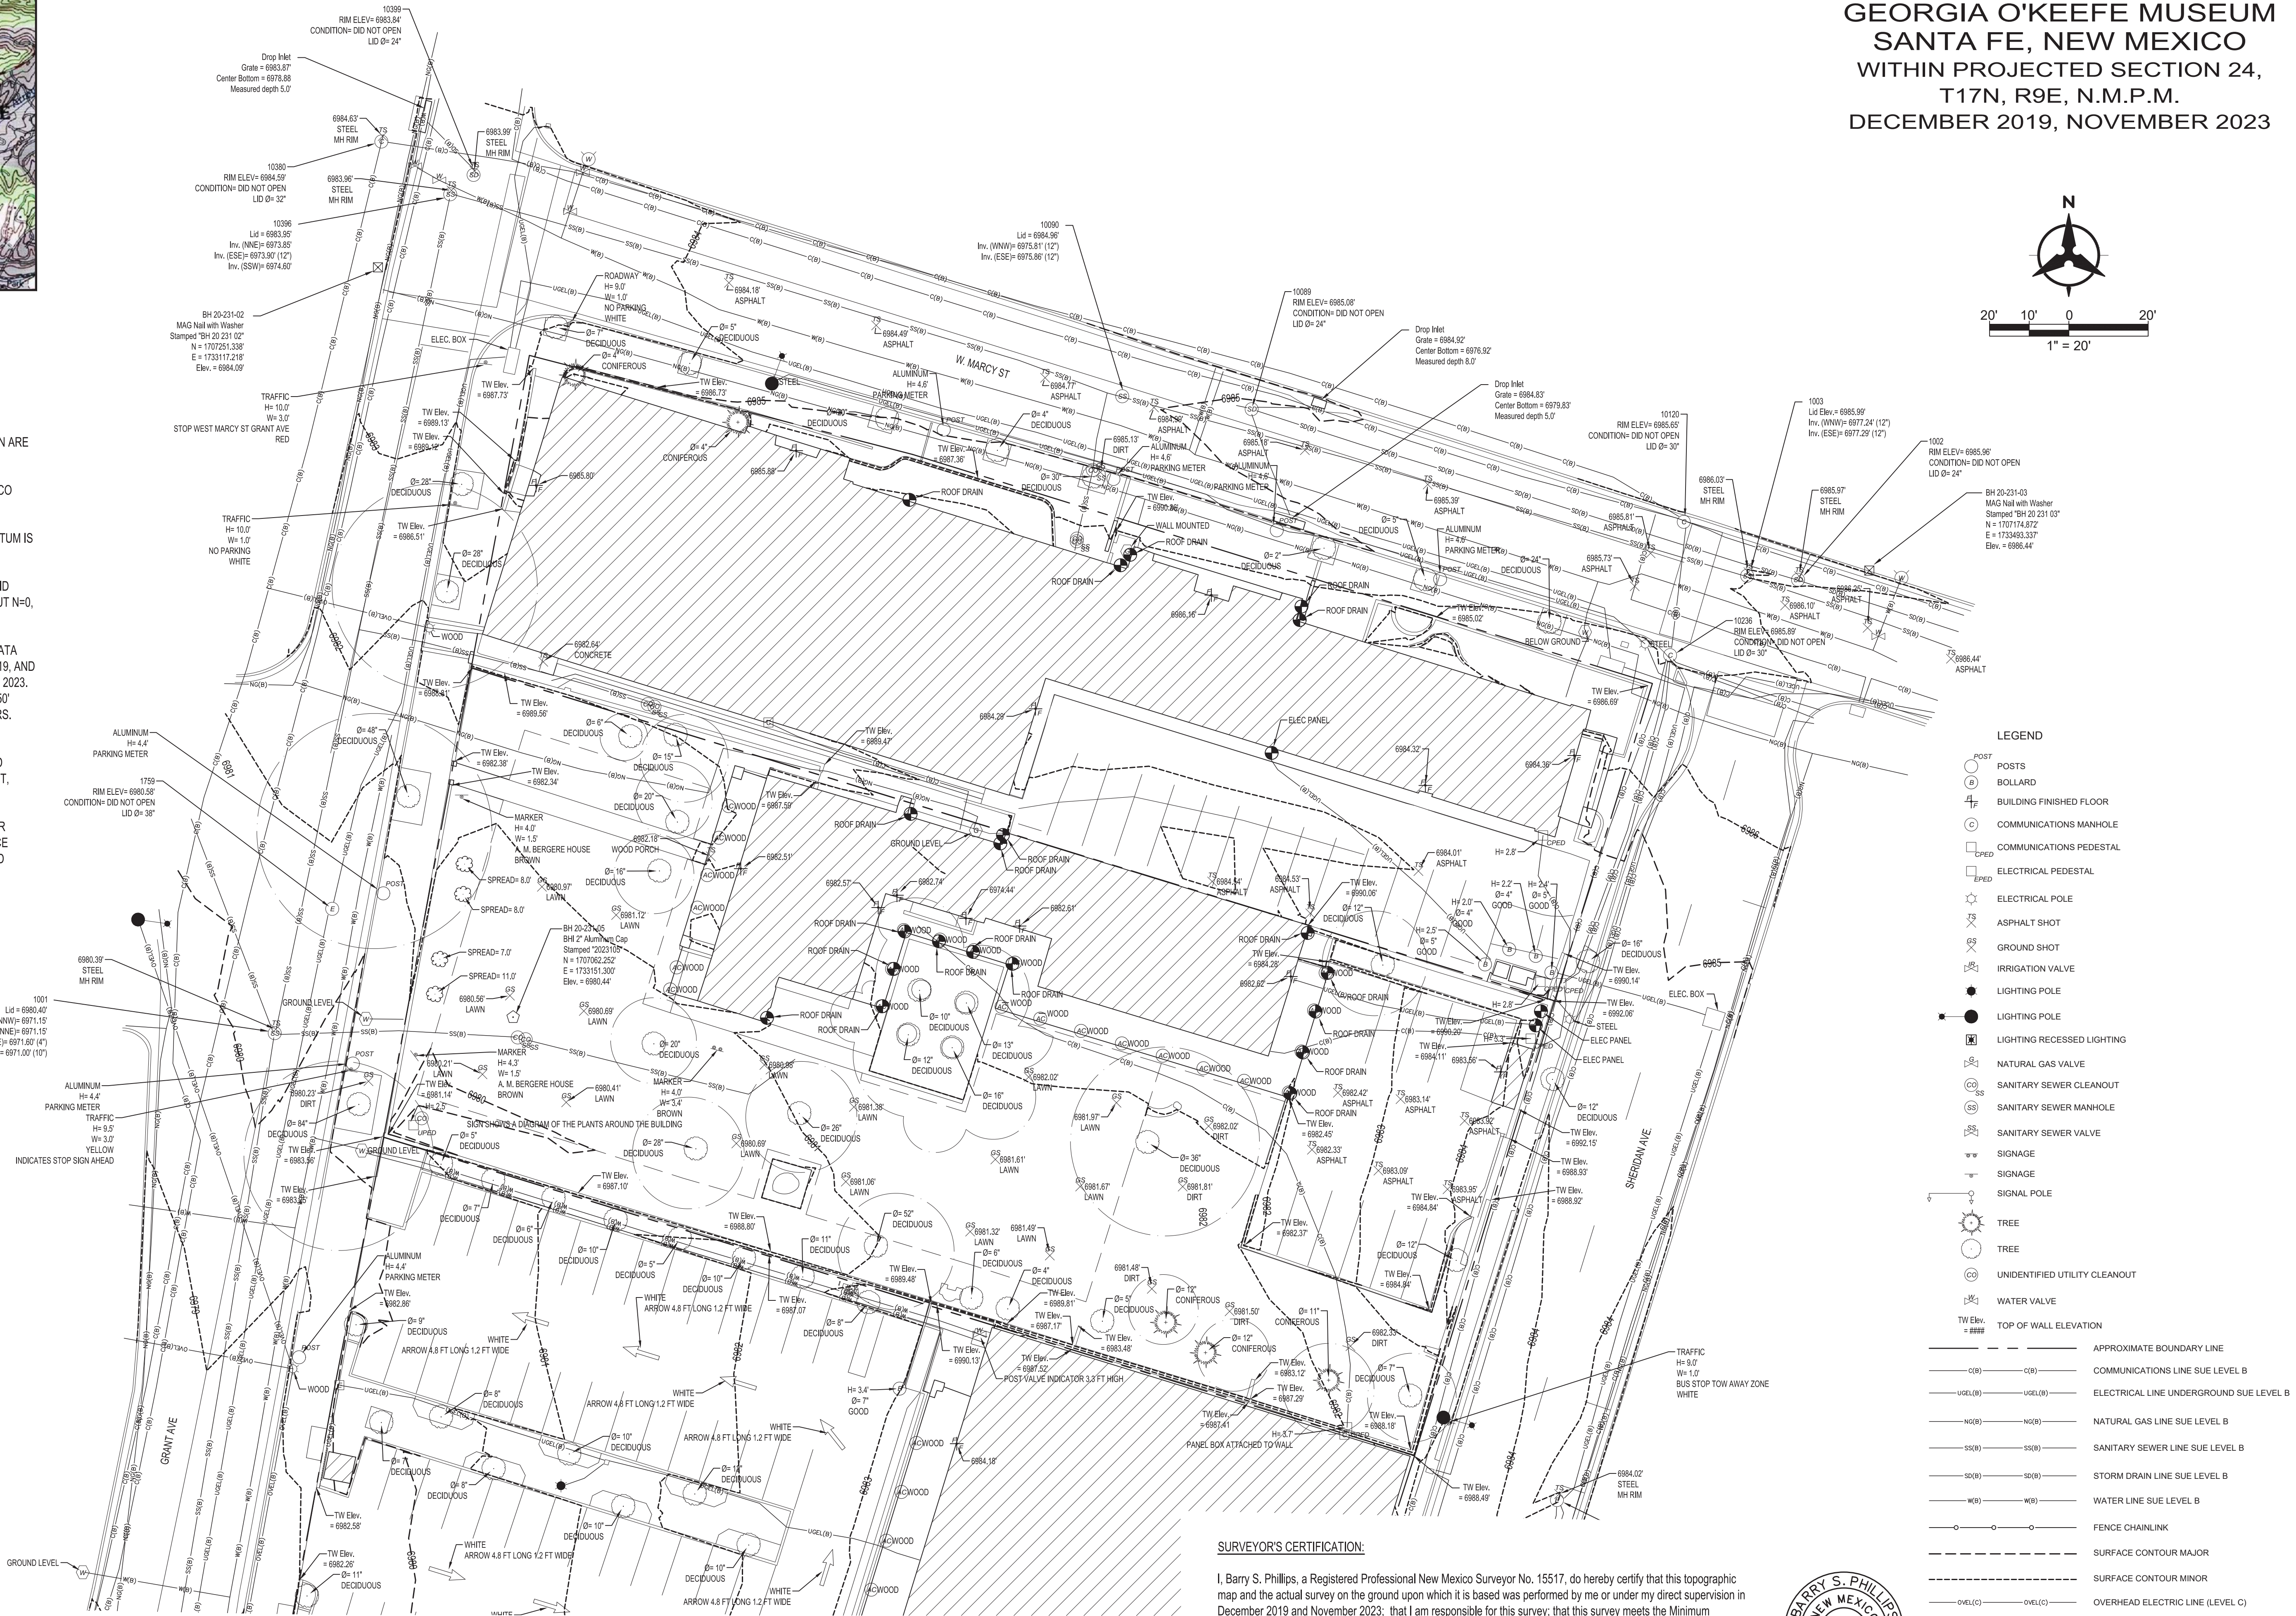
- UTILITIES SHOWN WERE LOCATED IN THE FIELD BY BHI STAFF, AS PER MARKS SPOTTED ON THE GROUND FROM SUE Level B UTILITY SERVICE PROVIDED BY HIGH MESA CONSULTING GROUP - SEE PLAN PROVIDED SEPARATELY AND DATED 11-2019.

TOPOGRAPHIC MAP
GEORGIA O'KEEFE MUSEUM
SANTA FE, NEW MEXICO
WITHIN PROJECTED SECTION 24,
T17N, R9E, N.M.P.M.
DECEMBER 2019, NOVEMBER 2023

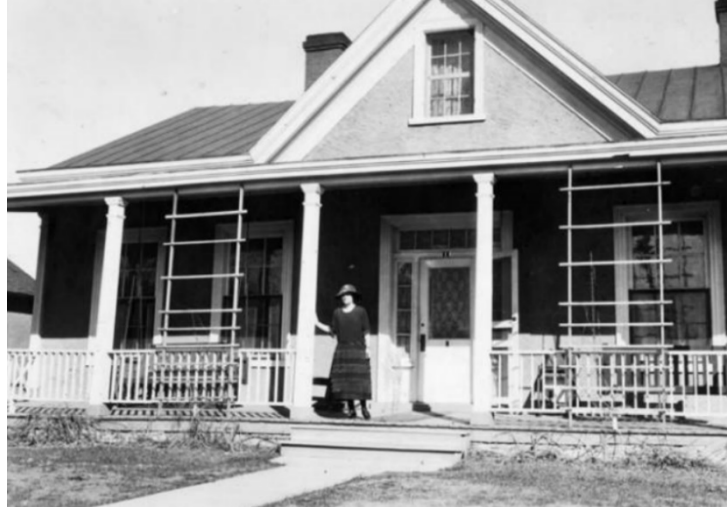
Figure 4-7. Photo from 1920 of R.N. Miller House at 123 Grant Avenue, whose location is within the project area. (Image from Montoya 2023)

Seven officer's houses were constructed in the early 1870s according to the Army's standardized "Plan C" type along Lincoln Avenue and Grant Avenue, including two at 123 Grant Avenue that evidently once stood within the current project area (Montoya 2023, Figure 4-5 through Figure 4-8). These houses all used identical floorplans, materials and detailing, each with side-gabled roof, front dormer, pair of interior brick chimneys, quoins, full width front porch, back porch, white Territorial Style trim, symmetrical front façade, centered front door, sidelights, transom and pairs of 6/6 double hung windows with green shutters. The floor plan of each house features a central hall that purposefully divided public and private spaces in the Anglo-American idealized tradition (Figure 4-5 and Figure 4-9). Each was likely of adobe on stone foundations. Landscape features included yards enclosed by white picket fences, symmetrically planted trees over possible lawn, walkways, cesspits, gardens and outbuildings, which likely included stables and outhouses. The two "Plan C" houses within the project area were owned by J.A. Martinez and R.N. Miller in 1912, at which time a smaller pre-1908 house owned by Mrs. Y. Roberts was in-between and included an apparent Shotgun type floor plan with partial-width front porch (Figure 4-6). The two houses in the southern part of the project area were demolished by 1948, by which time two larger apparent commercial buildings and a house had been built within the area (Figure 4-10). The A.M. Bergere House at 135 Grant Avenue still stands today as a surviving example of the "Plan C" officers houses, though was altered in 1926 with a flat roof and other modifications to conform with the Spanish-Pueblo Revival Style which was regionally popular at the time (Montoya 2023, Wilson 1997).

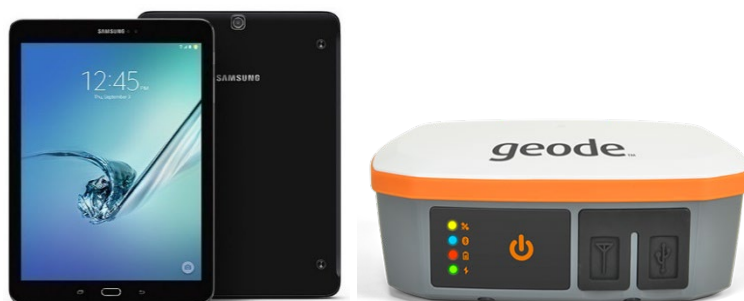
Figure 5-1. Samsung Galaxy tablet (left) and Geode GPS receiver.

post-field phases. We use two apps for in-field recording: Open Data Kit (ODK) Collect and a mobile data collection app. ODK Collect documents archaeological data (artifacts, features, etc.), and the mobile data collection app records spatial data (site and survey boundaries). Both programs run on Samsung Galaxy Android tablets connected to a Juniper Geode GPS receiver (Figure 5.1). In this way, each crew member has GPS access, which greatly expedites field recording. The Geode GPS receiver provides sub-meter spatial resolution. On a daily basis we will upload the data on each tablet to an SWCA-owned server and an ArcGIS Online fieldmap is automatically populated.

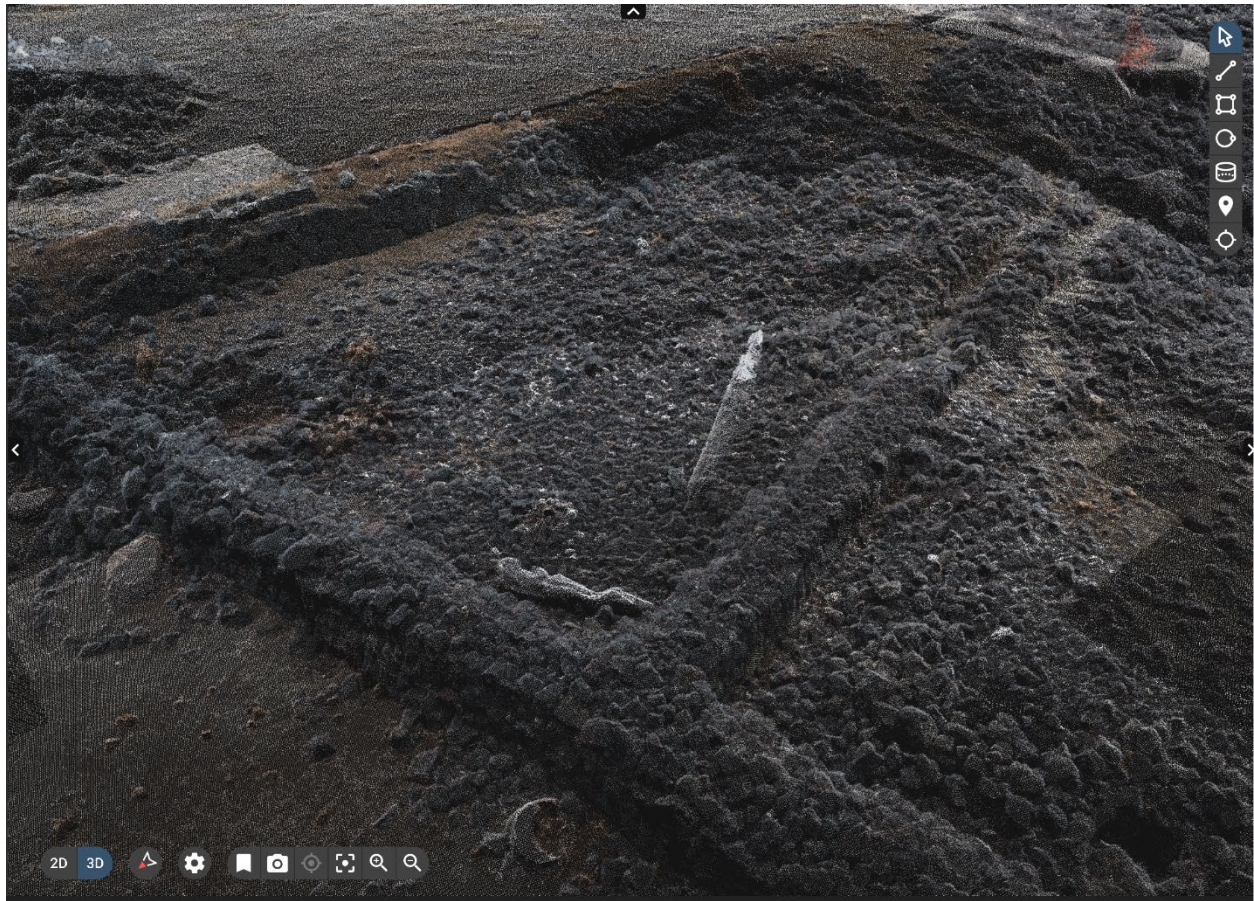
Figure 5-3. Walls rendered as a point cloud using photogrammetry.

The point cloud is produced by using photogrammetry, a technique using multiple photographs of the same object taken at different locations, distances, and angles to reconstruct the surface of the object. The point cloud is saved in the same format as LiDAR files (LAS format) and records UTM coordinates (latitude, longitude, and altitude) of each point, using the WGS 84 datum. All data will be transformed to NAD 83 UTM Zone N13 before being submitted to the BLM. The color of each point is also recorded, allowing for

almost photographic rendering of each mission with the web application (Figure 5-3). The point cloud is the basis of several products used in this analysis.

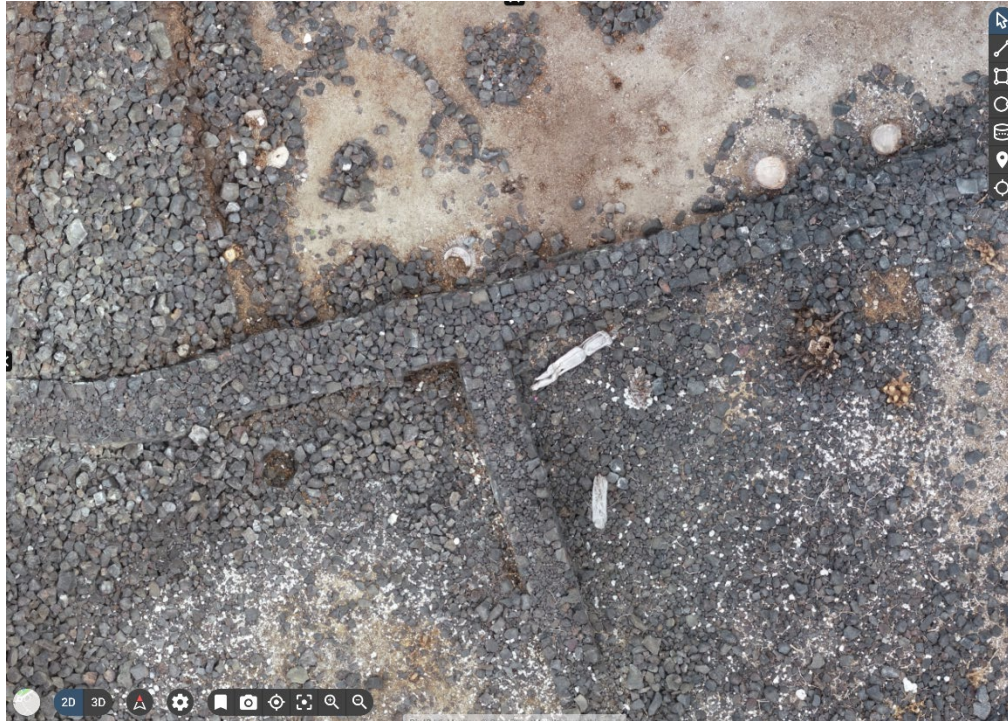
Figure 5-4. Walls visualized from low level drone flights using photogrammetry.

The orthomosaics are created and saved in a georeferenced TIFF format, either as one large image or tiled for faster viewing. The orthomosaics are created by taking pieces of each image and stitching them together using the point cloud as the base reference system. This is more sophisticated than normal photographic tiling and allows images from any angle to be merged into an orthomosaic. The orthomosaics provide an extremely high-resolution view of the site's surface, allowing for extremely detailed locational referencing for artifacts, features, etc. (Figure 5-4).

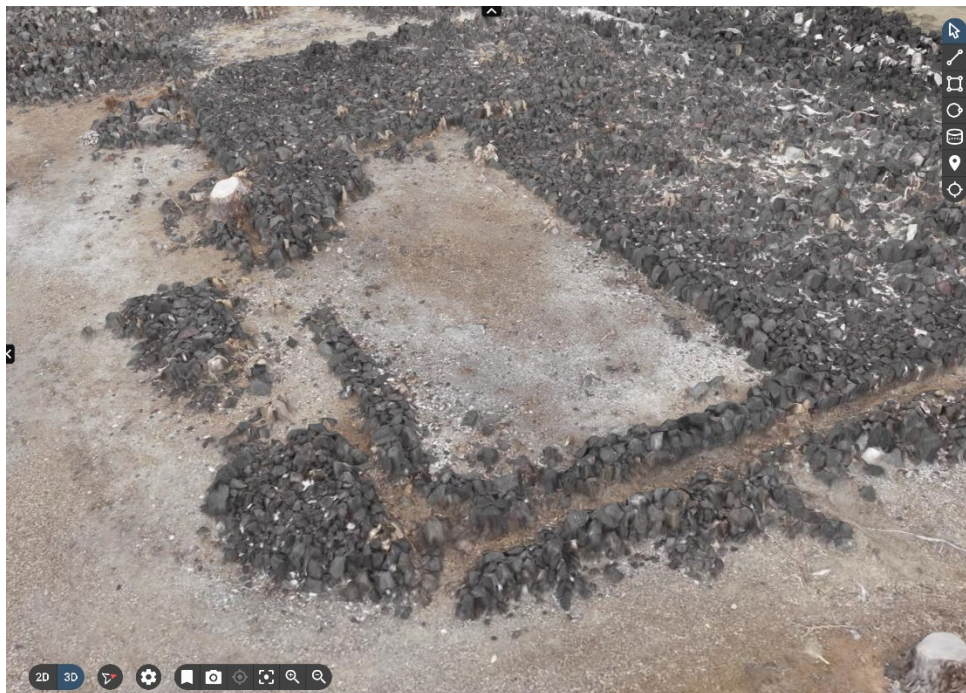
Figure 5-6. A 3D mesh representation of rock walls with a surface texture draped over the fine scale mesh model3D Point Cloud Production.

The photogrammetry data will also be used to create a 3D surface mesh, which can be viewed natively in Windows 3D viewer software (Figure 5-6). Point cloud production using the Leica BLK360 is a simple process of setting up the recorder and running the 360 scan in the area of interest. Since the scanner will be recording large open surfaces primarily it will be placed at an elevation of 5 feet or higher and at multiple points around the area to ensure proper recording of the surfaces. Within trenches or inside of excavation units, the scanner will be able to see the walls and features easily, with multiple set ups used to ensure full coverage. Every scan location will be able to see at least two of the permanent or sub-datums to allow for easy reconciliation of the data into the larger point cloud project. At the same time as the camera is scanning for points, it also records a 360 image of the location. This will also be useful for visualizing the excavations and will be archived with the point cloud data.

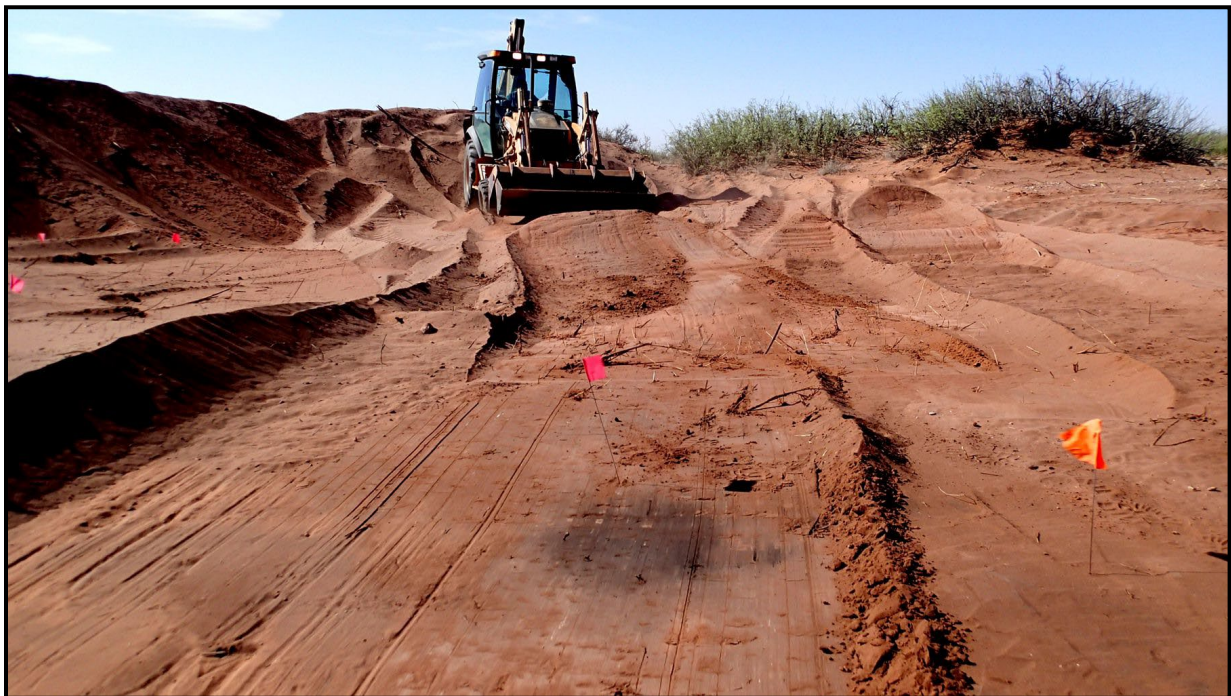
Figure 5-7. Example of machine scraping. Note the dark feature stain in the foreground.

Mechanical stripping (Figure 5-1) will be carried out at LA 200086 in order to assist in delineating the extent of features and to remove overburden. Any archaeological features uncovered during machine scraping will be flagged and geospatially located using the RTK/GNSS system, and further scraping will be used to remove overburden to within 20 cm of the feature. Uncovered features will be documented and manually excavated per standard feature methods (see below). Temporally diagnostic artifacts observed during stripping will be collected by point provenience using the GNSS receiver. Depending on specific circumstances, scraping may resume at a particular locus within the site following excavation of exposed features. An archaeologist will monitor machine scraping at all times, and appropriate safety measures will be implemented.

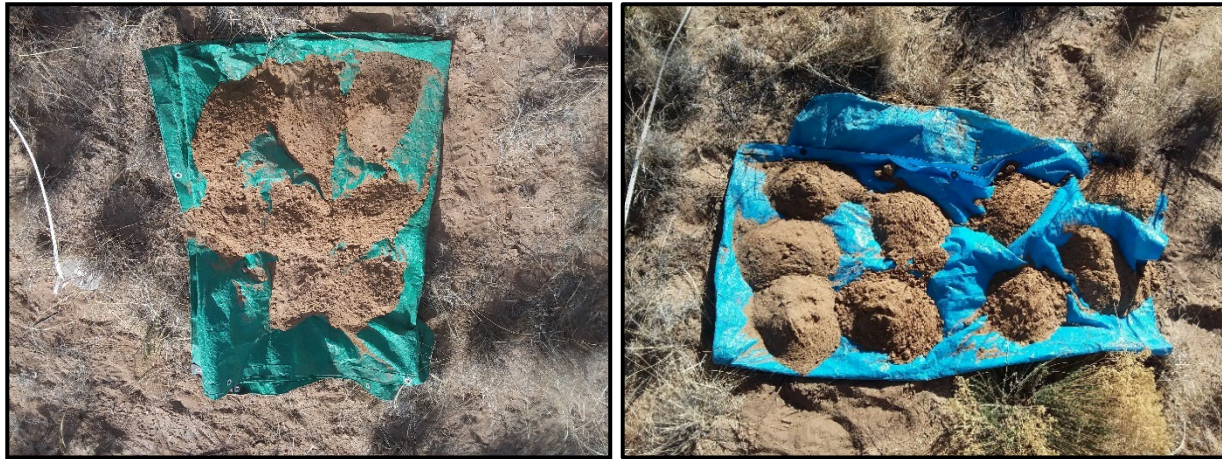
Figure 5-8. Examples of extracted sediment from auger tests, laid out by level.

augers at each site, and will include the following fields: 1) auger number, 2) FS number and 3) QR numbers (if any artifacts are recovered and collected), 4) maximum depth, 5) depth of any observed stratigraphic break, 6) photograph (if applicable), and 7) notes. If the auger tests indicate subsurface cultural materials or deposits, then the hand unit will be excavated down to that level to fully investigate the cultural deposit.

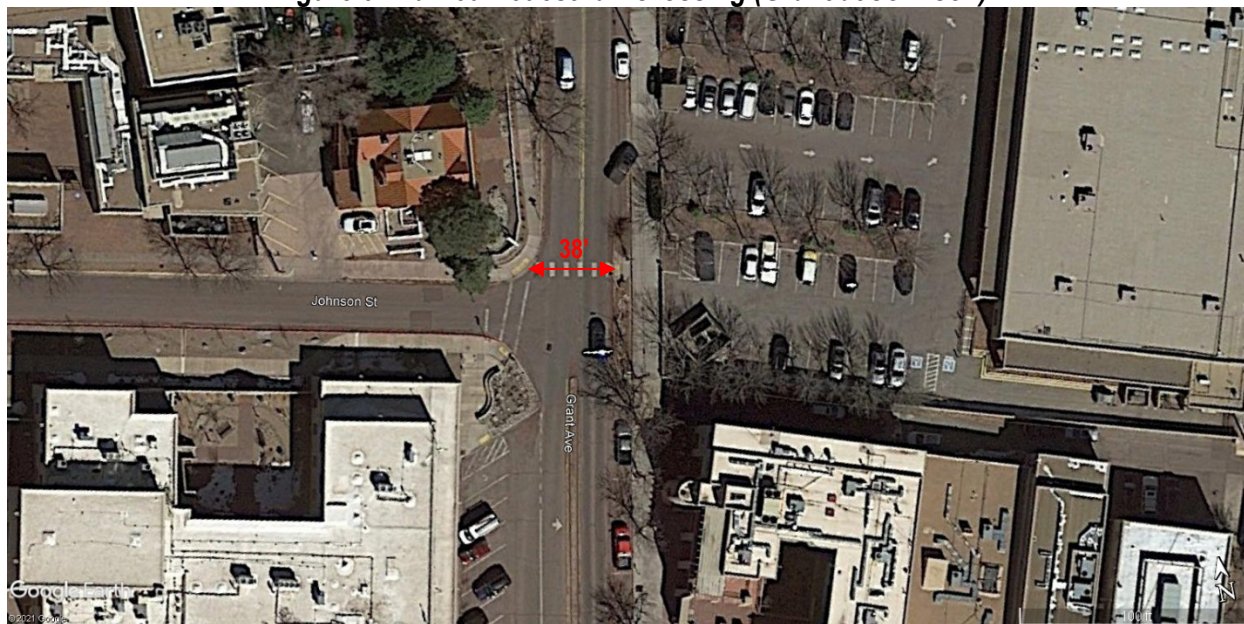
Figure 5: Marked Pedestrian Crossing (Grant at Johnson)

Marked crosswalks provide access across Grant Ave. at Sandoval St., Johnson St. north side, and at Marcy St. Under a project of indeterminate origin, the marked crosswalk on the north side of Johnson St. was installed along with a bump-out on the east side to reduce crossing distance, passive pedestrian detection, signing, and in-pavement flashing beacons although the in-pavement flashing beacons no longer operate (Figure 5). The purpose of this analysis was to determine whether adequate gaps in the traffic stream exist to accommodate pedestrian crossings, whether the crossing still meets demand, or whether it should be eliminated or certain modifications should be made.

Values that are commonly applied include: $S_p = 4.0$ or 3.5 ft/sec and $t_s = 3$ sec. The roadway section consists of two and on-street parking. The full width to be crossed is $L = 38$ feet. Given the prevalence of older pedestrians observed, the walking speed of 3.5 ft/sec was used. From the equation above, the critical gap was $t_c = 13.85$ sec, rounded to 14 sec. Concurrent with the TMCs, gap counts were conducted during the AM and PM peak periods using an electronic counter board with a gap study template that records gaps by direction with time stamps that are then processed through proprietary software to tabulate the gaps.

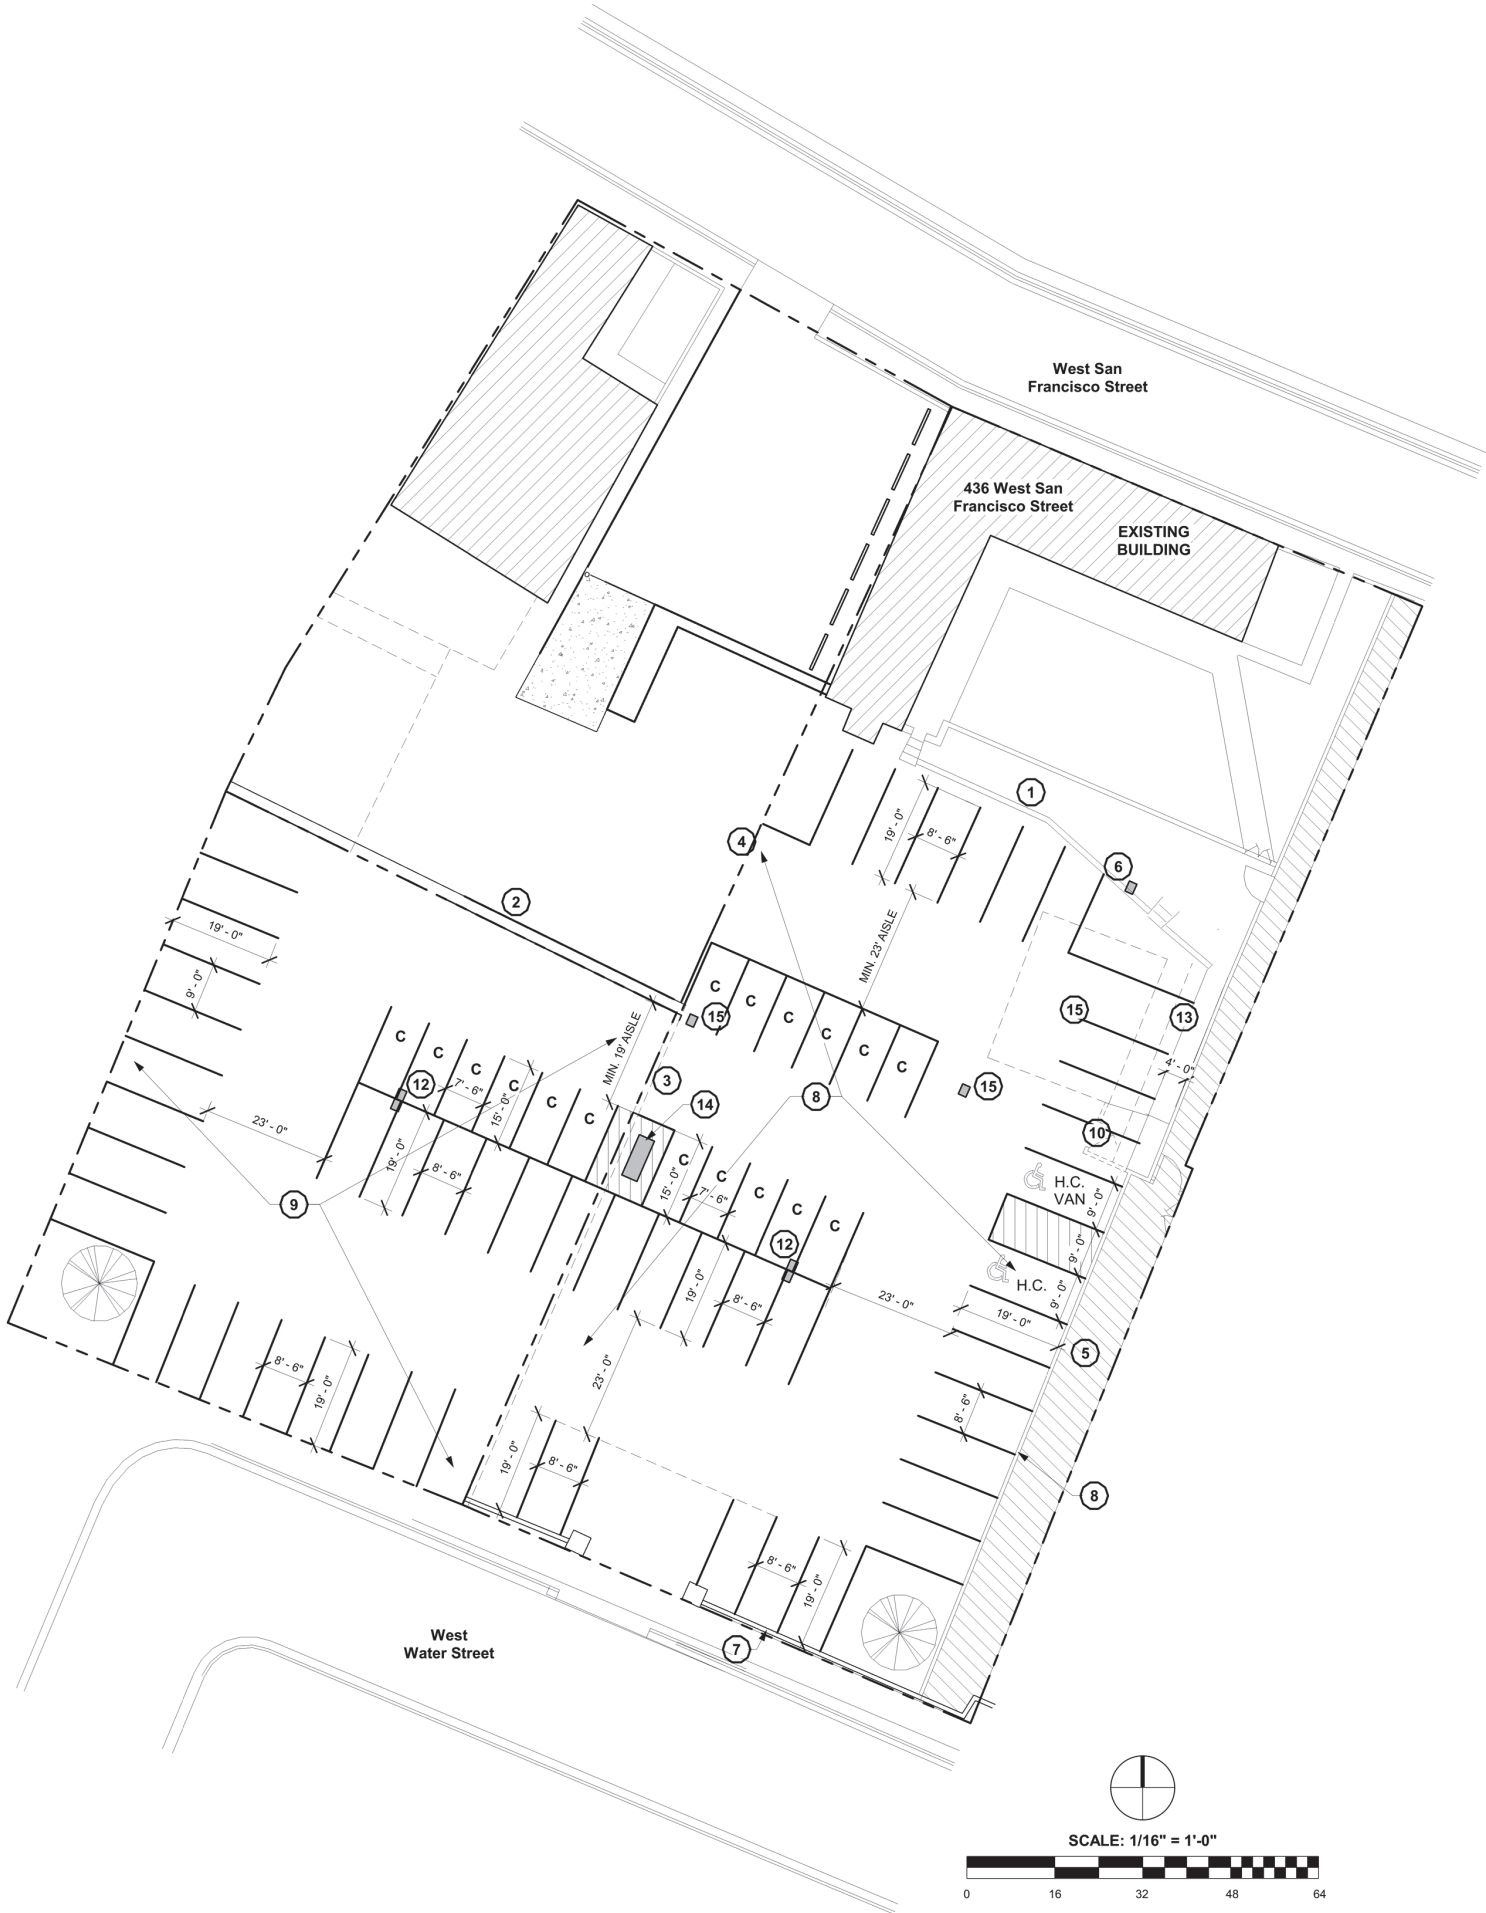
- 1
- EXISTING STONE WALL AND STEPS TO REMAIN
- 2
- EXISTING WALL TO REMAIN
- 3
- DEMOLISH WALL
- 4
- EXISTING COYOTE FENCE AND GATE TO REMAIN
- 5
- PEDESTRIAN EASEMENT FOR VANESSIE ONLY
- 6
- EXISTING LIGHT POLE TO REMAIN
- 7
- EXISTING WALL AND PILASTERS TO REMAIN
- 8
- REPAVE EXISTING LOT - REMOVE EXISTING 2" TO 3" LAYER - REPAVE WITH 3" ASPHALT. RESTRIPE AS SHOWN WITH 4" WHITE REFLECTIVE TRAFFIC PAINT.
- 9
- PAVE EXISTING GRAVEL LOT WITH 3" ASPHALT - RESTRIPE AS SHOWN
- 10
- REMOVE REMOVE EXISTING FENCING AND GATES
- 11
- EXISTING POLE LIGHT TO BE REMOVED
- 12
- NEW POLE LIGHT - SEE DETAIL
- 13
- SAWCUT AND REMOVE PORTION OF CONCRETE RAMP UP TO 4' FROM FENCE LINE
- 14
- PARKING PAY STATION, WALK-UP PAY-BY-SPACE "MINI PAY BOXX" SMART PARKING METER BY PARKING BOXX WITH 4G MODEM, 2D SCANNER, P-123 PAY-BY-PHONE AND VALIDATION
- 15
- DEMOLISH STORAGE SHED

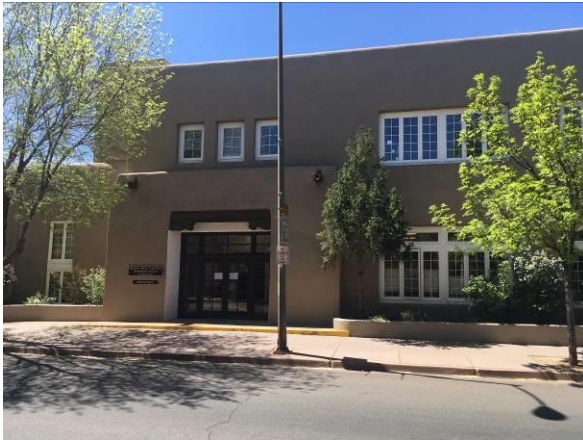
Photo #1 View of the front of the Marcy Street Offices (MSO) (155 Grant Avenue / 200 West Marcy Street) facing south.

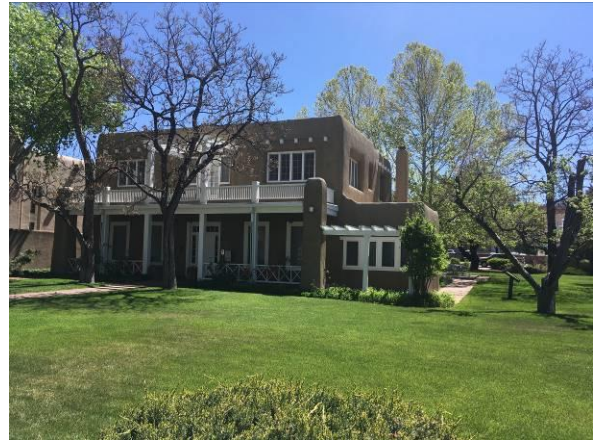
Photo #2 View of the front of the Bergere House (135 Grant Avenue) facing east.

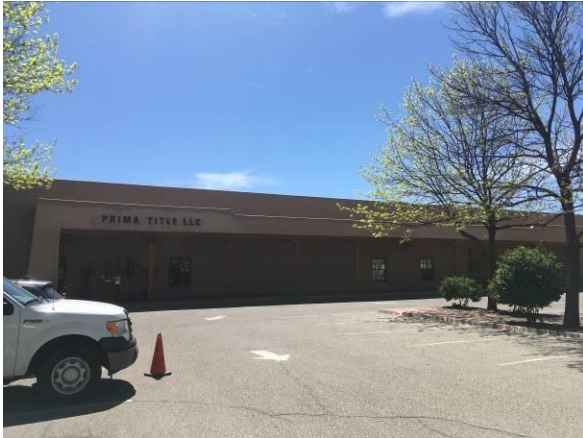
Photo #3 View of the Grant Street Offices (GSO) (123 Grant Avenue) facing east.

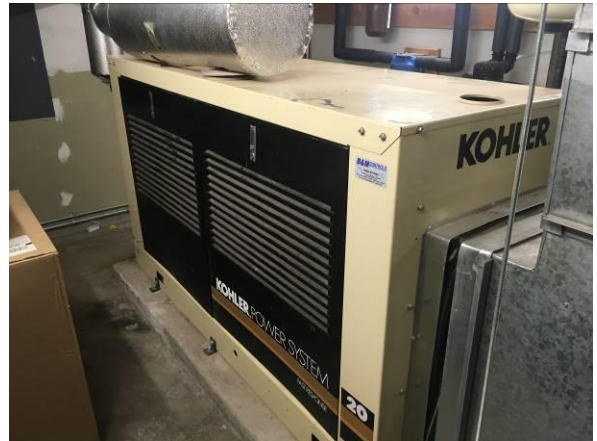
During the site reconnaissance, a natural gas-fired generator, two elevator mechanical rooms, multiple interior floor drains, three pad-mounted transformers, and a dumpster were observed. Indications of RECs were not identified.

Photo #10 View of natural gas-fired generator located in the sub-grade boiler room of the Bergere House.

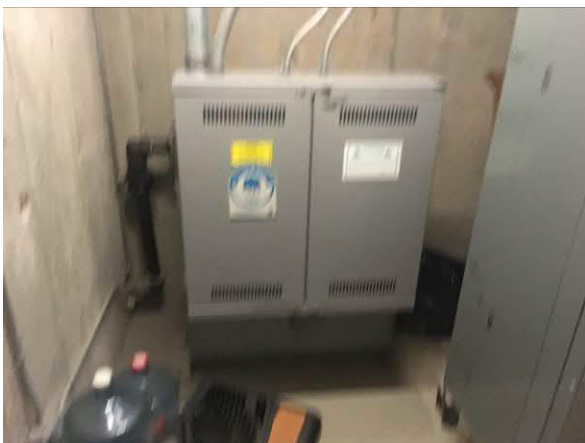
Photo #11 View of elevator mechanical room located in the basement area of the Bergere House.

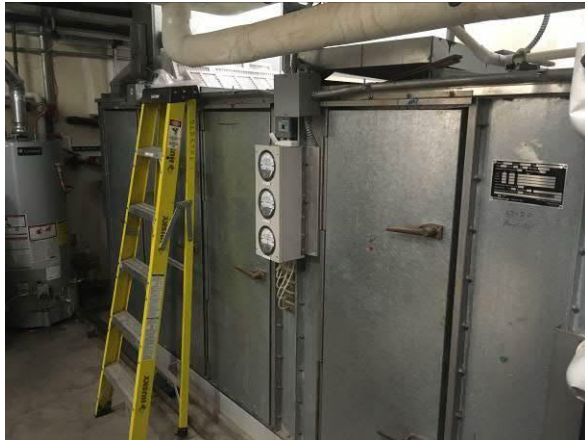
Photo #13 View of boiler located in the sub-grade boiler room of the Bergere House.

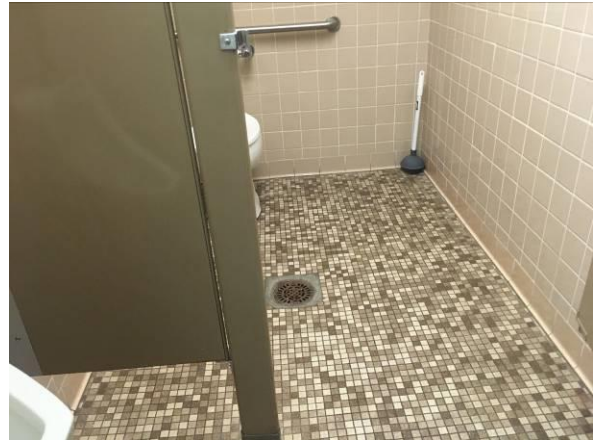
Photo #14 View of one of multiple floor drains located throughout the on-site buildings.

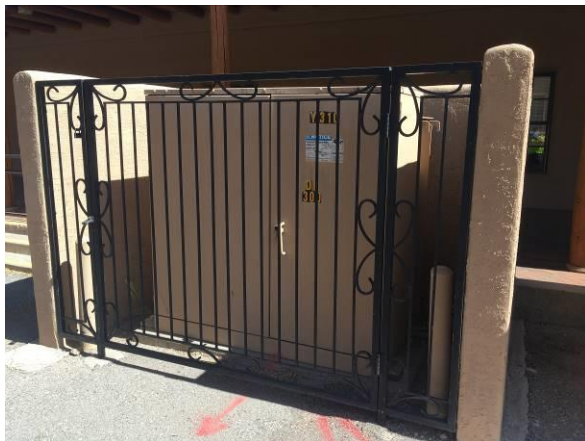
Photo #15 View of one of three pad-mounted transformers located in the southern and northern portions of the site.

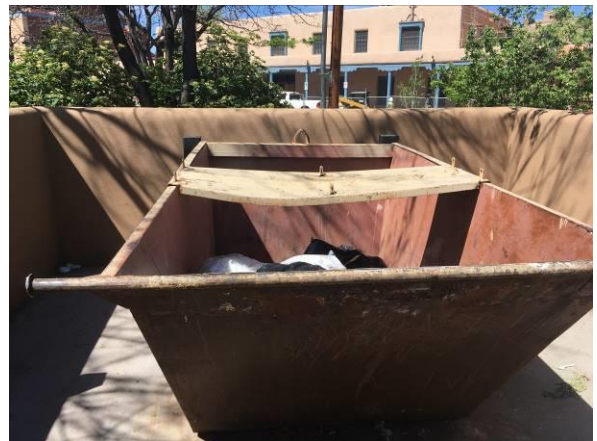
Photo #16 View of solid-waste disposal dumpster located near the southwestern boundary of the site.
